## An Experimental Investigation of the Failure of a Stepped Composite Plate

Thesis by  
Steven C. Gortsema

In Partial Fulfillment of the Requirements for the Degree of  
Aeronautical Engineer

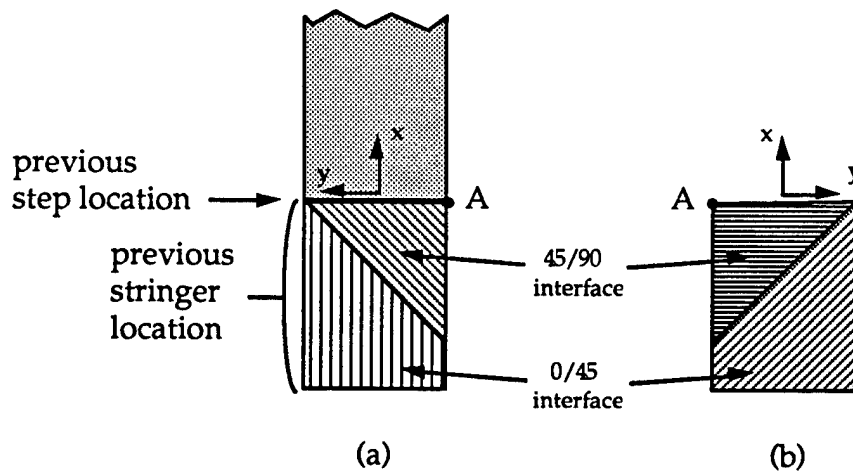
The details of the 45/0 delamination are most easily recognized by analyzing the fracture surface. In all of the case 1 and 4 specimens, the fracture surface can be represented by Figure 24.

Figure 24. Fracture surface of case 1 and 4 specimens. (a) Plate side of the fracture surface. (b) Stringer side of the fracture surface.

Also, a significant opening stress in this region due to bending would require a sizable change in bending stiffness between the portion of the plate with the 90° plate interface ply and the portion without it. This also does not occur. Therefore, the stress levels needed to delaminate the 90/45 interface on the +x side of the step do not exist. This makes it clear why the fracture surface consistently appeared as shown in Figure 24.
